MODEL/YEAR MODÈLE / ANNÉE	DATE OF ISSUE DATE EN VIGUEUR	BULLETIN NUMBER NUMÉRO DU BULLETIN
2017 CIVIC SI	DEC. 21, 2017	B-1-17

NOISE FROM THE REAR SUSPENSION IN COLD TEMPERATURES

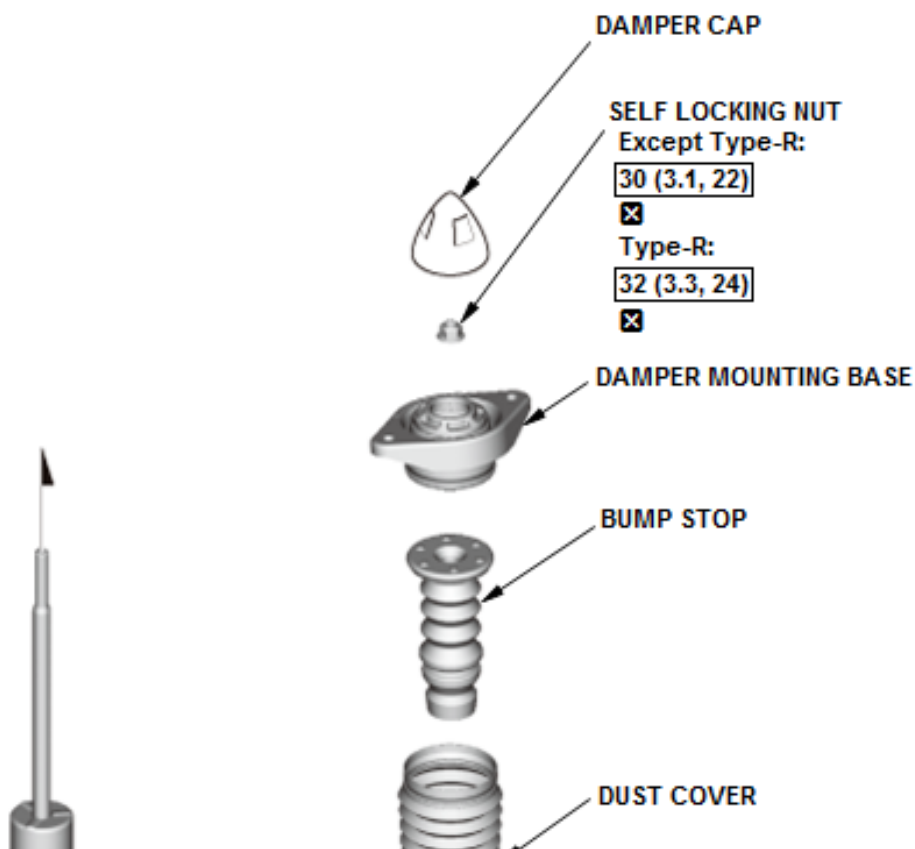
On some early production 2017 Civic Si models, there may be a noise from the rear suspension area when driving over bumps in temperatures below freezing (typically below -10°C). The most probable cause is insufficient noise isolation from the rear damper mounting base. To correct the problem, follow the repair procedure to install a new improved damper mounting base on both sides.

1. Remove the rear dampers: [Rear damper removal](#).
2. Remove the damper mounting base by removing the damper cap and the self-locking nut.

3. Install the new damper mounting base with a new self-locking nut and torque to 30 N·m (22 lbf·ft).
4. Reinstall the damper cap and reinstall the rear damper: [Rear damper installation](#).
5. Repeat steps 2 to 5 for the opposite side.
