February 15, 2018

07152 Version 1

Audio Unit/Audio-Navigation Unit Update: XM Check Tuner Message, GPS Signal, Trip A History

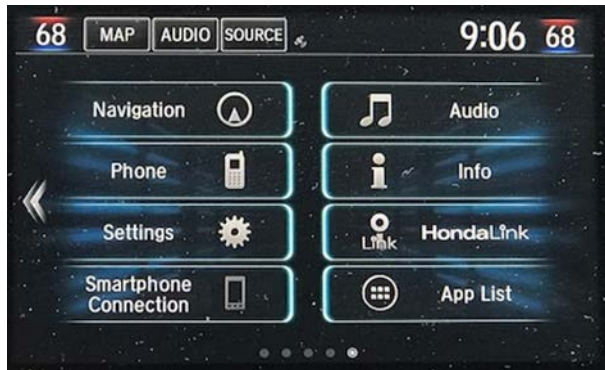
6. Press and hold the Day/Night button, along with the **AUDIO**, and **MENU** icons at the same time.

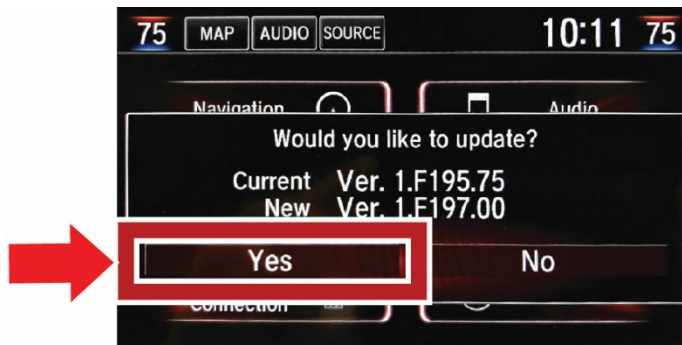
12. After the system reboots, the software update will start automatically. After the update has started, the installation is automatic and the technician does not need to stay with the vehicle.

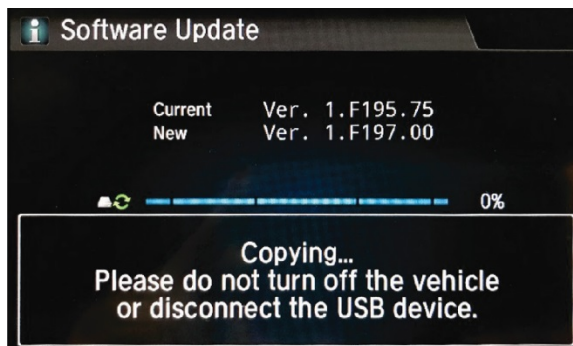
13. After the software update is complete, remove the USB update device and press **Continue**.
